**Flood Control Project Maintenance
Levee Inspections**

Maintenance Issue Types Only, Levee Inspection Report By Mile - Spring 2019

Sacramento Maintenance Yard Willow Slough Bypass

Waterway	Bank	Unit Miles	Inspection Start/End	Inspector
Unit No. 01 Willow Slough Bypass or North Levee	Left	5.05	04/30/2019 04/30/2019	Zach Jojola

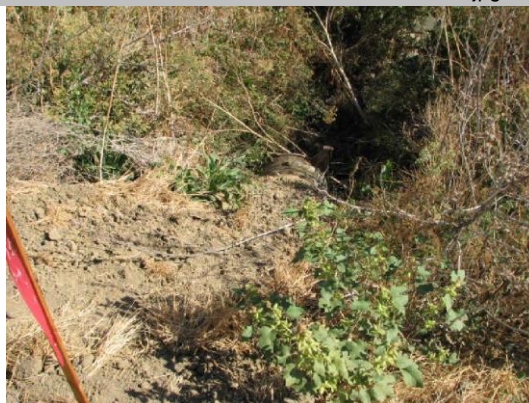
Photo 2 of 3 : UCIP_SP_2019_45286_22460.jpg

Waterside view- overview

Comment Code						
Inspector Comment						
FS_ID:45286 DS_ID:534 EP_NO: 10327 Repair Type: No Action Needed Crossing Status: Found UCIP Comments: 04/12/2017 WS & LS - good/clear, inspected by JK, RF. (DWR Sacramento Yard - C. Lund) 05/24/2013 Flap gate repaired. (DWR Sacramento Yard - C. Lund) 09/20/2012 Flap gate is not properly closing. (DWR UCIP - P. Amatya) FIELD_STRUCT_DESC: 24-inch corrugated drainage pipe through the levee, 17.5 feet below the crown. Flap gate is located on the waterside (WS) slope. (24-inch pipe [HLM 0.78] authorized under Automatic Board Order (ABO) issued as Permit No. 10327 - Heidrick). [Additional Reference(s): DWR Levee Log, 1990. USACE Sacramento O&M Manual Unit 120, Willow Slough Channel Relocation and Levee Construction, February 1947, Drawing No. 50-4-2281 Sheet 1 (Station 47+00)] FS Date: 5/14/2015 1:36:52 PM

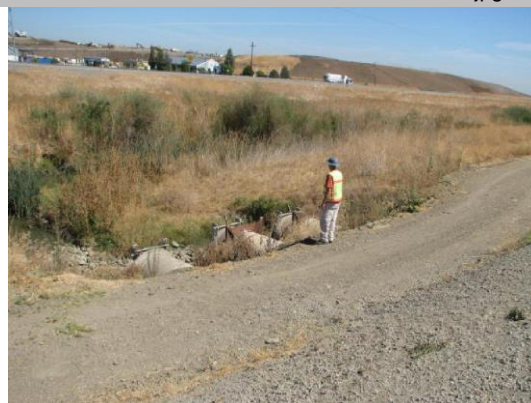
Photo 2 of 3 : UCIP_SP_2019_45294_22788.jpg

Waterside overview-

Comment Code						
Inspector Comment						
FS_ID:45294						
DS_ID:541						
EP_NO: 10335						
Repair Type: No Action Needed						
Crossing Status: Found						
UCIP Comments: 09/20/2012 Landside view photos are missing.						
Daylight pipe is a steel pipe. The pipe through the levee may be a CMP.						
(DWR UCIP - P. Amatya)						
FIELD_STRUCT_DESC: 1 of 2. 42-inch corrugated metal drainage pipe						
through the levee, 12 feet below the crown. Flap gate located on the						
waterside (WS) end. 42-inch pipe sleeved through a 48-inch corrugated						
metal pipe (CMP). (two 48-inch pipes [HLM 3.54] authorized under						
Automatic Board Order (ABO) issued as Permit No. 10335, 1974 -						
Snyder). [Additional Reference(s): DWR Levee Log, 1990. USACE						
Sacramento O&M Manual Unit 120, Willow Slough Channel Relocation						
and Levee Construction, February 1947, (Station 192+80)]						
FS Date: 5/14/2015 1:41:55 PM

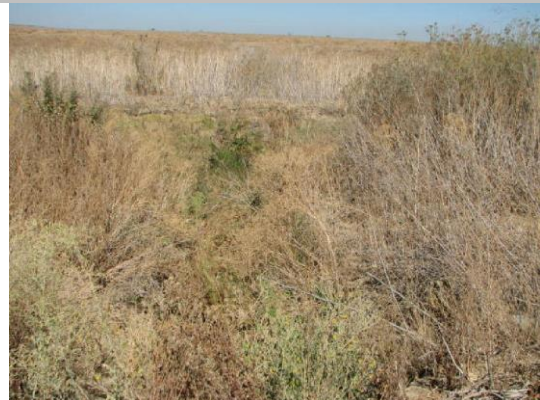
Photo 2 of 3 : UCIP_SP_2019_45298_22804.jpg

Landside overview

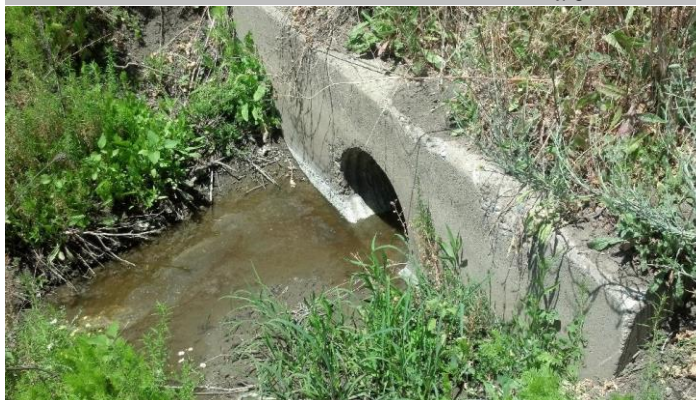
Photo 3 of 3 : UCIP_SP_2019_45298_22808.jpg

Item	DWR UCIP LMA Responsibility		38.589530 °	38.589530 °								
			-121.680560 °	-121.680560 °								
DWR ID	545											
Comment Code												
Inspector Comment												
FS_ID:45298 DS_ID:545 EP_NO: 10334 Repair Type: No Action Needed Crossing Status: Found UCIP Comments: 04/12/2017 WS - good/clear, LS - good/clear needs to be cut and sprayed, inspected by JK, RF. (DWR Sacramento Yard - C. Lund) 05/24/2013 Rodent activities on headwall is far from the levee. Inlet is across city of davis drainage ditch. Inlet was cleaned last fall. see picture. (DWR Sacramento Yard - C. Lund) 09/20/2012 May need video inspection as seen rodent activities on headwall. (DWR UCIP - P. Amatya) FIELD_STRUCT_DESC: 24-inch corrugated metal drainage pipe through the levee, 13.5 feet below the crown. Flap gate is located on the waterside (WS) end. (24-inch pipe [HLM 4.21] authorized under Automatic Board Order (ABO) issued as Permit No. 10334 - Rhinehart) [Additional Reference(s): DWR Levee Log, 1990. USACE Sacramento O&M Manual Unit 120, Willow Slough Channel Relocation and Levee Construction, February 1947, Drawing No. 50-4-2281 Sheet 2 (Station 228+46)] FS Date: 5/14/2015 1:43:00 PM

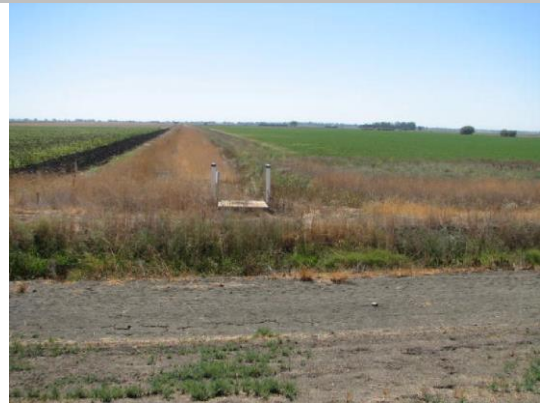
Photo 1 of 3 : UCIP_SP_2019_45301_22845.jpg

Comment Code					
Inspector Comment					
FS_ID:45301 DS_ID:548 EP_NO: 10321 Repair Type: No Action Needed Crossing Status: Found UCIP Comments: 04/12/2017 WS - good/clear, inspected by JK, RF. (DWR Sacramento Yard - C. Lund) FIELD_STRUCT_DESC: 24-inch drainage pipe through the levee, 17 feet below the crown. Flap gate is located on the waterside (WS) end. (24-inch pipe [HLM 4.97] authorized under Automatic Board Order (ABO) issued as Permit No. 10321, 1974 - Campbell) [Additional Reference(s): DWR Levee Log, 1990. USACE Sacramento O&M Manual Unit 120, Willow Slough Channel Relocation and Levee Construction, February 1947, Drawing No. 50-4-2281 Sheet 4 (Station 268+57)] FS Date: 5/14/2015 1:44:17 PM

Landside view- overview

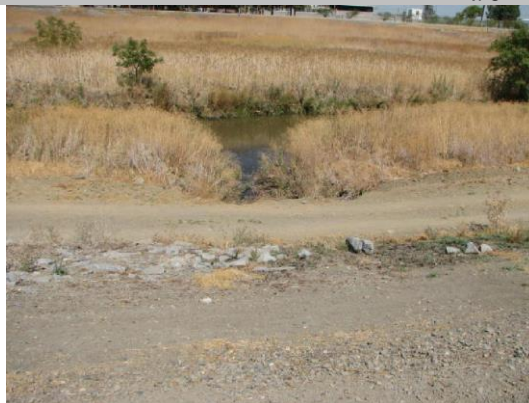
Photo 2 of 3 : UCIP_SP_2019_45301_22844.jpg

Comment Code						
Inspector Comment						
FS_ID:45301 DS_ID:548 EP_NO: 10321 Repair Type: No Action Needed Crossing Status: Found UCIP Comments: 04/12/2017 WS - good/clear, inspected by JK, RF. (DWR Sacramento Yard - C. Lund) FIELD_STRUCT_DESC: 24-inch drainage pipe through the levee, 17 feet below the crown. Flap gate is located on the waterside (WS) end. (24-inch pipe [HLM 4.97] authorized under Automatic Board Order (ABO) issued as Permit No. 10321, 1974 - Campbell) [Additional Reference(s): DWR Levee Log, 1990. USACE Sacramento O&M Manual Unit 120, Willow Slough Channel Relocation and Levee Construction, February 1947, Drawing No. 50-4-2281 Sheet 4 (Station 268+57)] FS Date: 5/14/2015 1:44:17 PM

Waterside view- overview

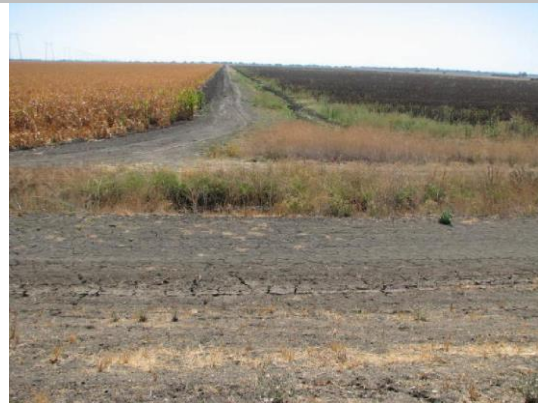
Photo 1 of 3 : UCIP_SP_2019_45302_22849.jpg

Comment Code					
Inspector Comment					
FS_ID:45302 DS_ID:549 EP_NO: 10322 Repair Type: No Action Needed Crossing Status: Found UCIP Comments: 04/12/2017 WS - submerged in water, inspected by JK, RF. (DWR Sacramento Yard - C. Lund) FIELD_STRUCT_DESC: 24-inch corrugated metal drainage pipe through the levee, 17.5 feet below the crown. Flap gate is located on the waterside (WS) end. Concrete headwall with wing walls is located on WS. (24-inch pipe [HLM 5.32] authorized under Automatic Board Order (ABO) issued as Permit No. 10322, 1974 - Chew). [Additional Reference(s): DWR Levee Log, 1990. USACE Sacramento O&M Manual Unit 120, Willow Slough Channel Relocation and Levee Construction, February 1947, Drawing No. 50-4-2281 Sheet 4 (Station 287+19)] FS Date: 5/14/2015 1:44:30 PM

Landside view-overview

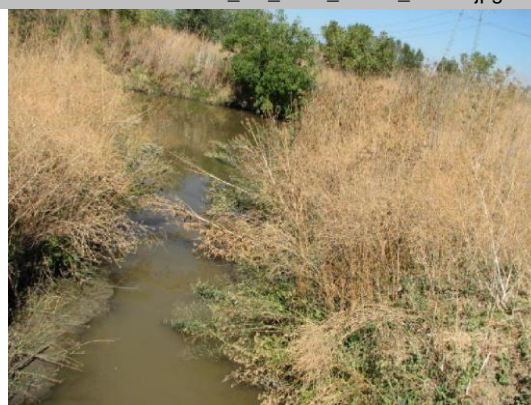
Photo 3 of 3 : UCIP_SP_2019_45302_22847.jpg

Waterside view- overview

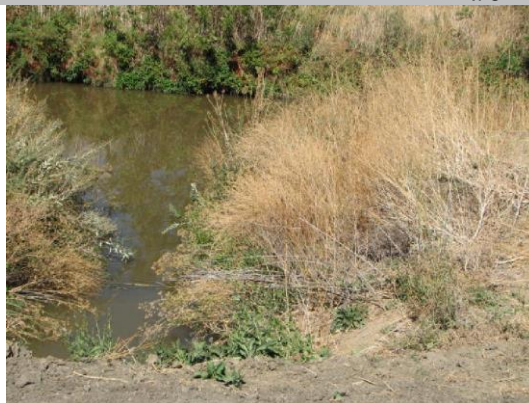
Photo 3 of 3 : UCIP_SP_2019_45305_22859.jpg

Comment Code						
Inspector Comment						
FS_ID:45305 DS_ID:551 EP_NO: 10325 Repair Type: No Action Needed Crossing Status: Found UCIP Comments: 04/12/2017 WS & LS - submerged in water, inspected by JK, RF. (DWR Sacramento Yard - C. Lund) 09/20/2012 Slide gate on landside of the levee over the field. (DWR UCIP - P. Amatya) FIELD_STRUCT_DESC: 24-inch corrugated metal drainage pipe through the levee, 18 feet below the crown. Flap gate is located on the waterside (WS) end. (24-inch pipe [HLM 5.50] authorized under Automatic Board Order (ABO) issued as Permit No. 10325, 1974 - Ferris). [Additional Reference(s): DWR Levee Log, 1990. USACE Sacramento O&M Manual Unit 120, Willow Slough Channel Relocation and Levee Construction, February 1947, Drawing No. 50-4-2281 Sheet 4 (Station 296+34)] FS Date: 5/14/2015 1:45:21 PM

Waterside view- overview.

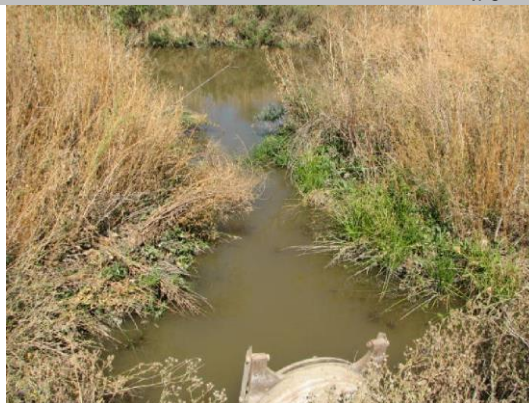
Photo 1 of 3 : UCIP_SP_2019_45306_22873.jpg

Comment Code					
Inspector Comment					
FS_ID:45306					
DS_ID:552					
EP_NO: 10338					
Repair Type: No Action Needed					
Crossing Status: Found					
UCIP Comments: 04/12/2017 WS - submerged in water, inspected by JK, RF. (DWR Sacramento Yard - C. Lund)					
09/20/2012 Open inlet over the field. (DWR UCIP - P. Amatya)					
FIELD_STRUCT_DESC: 36-inch corrugated metal drainage pipe through the levee, 19 feet below the crown. Flap gate is located on the waterside (WS) end. (36-inch pipe [HLM 5.51] authorized under Automatic Board Order (ABO) issued as Permit No. 10325, 1974 - Ferris) [Additional Reference(s): DWR Levee Log, 1990. USACE Sacramento O&M Manual Unit 120, Willow Slough Channel Relocation and Levee Construction, February 1947, Drawing No. 50-4-2281 Sheet 4 (Station 297+26)]					
FS Date: 5/14/2015 1:45:32 PM

Waterside view- overview.

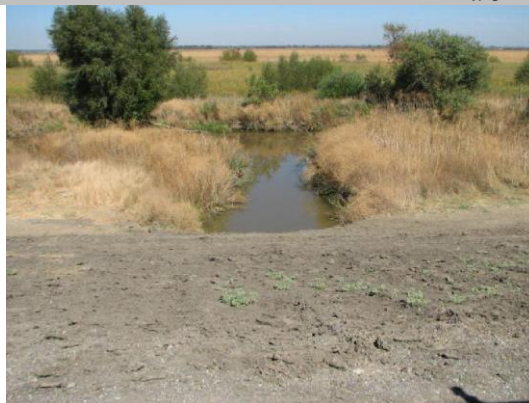
Photo 1 of 3 : UCIP_SP_2019_45307_22869.jpg

Comment Code					
Inspector Comment					
FS_ID:45307 DS_ID:553 EP_NO: 10325 Repair Type: No Action Needed Crossing Status: Found UCIP Comments: 04/12/2017 WS - submerged in water, inspected by JK, RF. (DWR Sacramento Yard - C. Lund) 09/20/2012 Outlet structure under water in waterside of the levee. No access to the inlet structure. (DWR UCIP - P. Amatya) FIELD_STRUCT_DESC: 24-inch corrugated metal drainage pipe through the levee, 18 feet below the crown. Flap gate is located on the waterside (WS) end. (24-inch pipe [HLM 5.98] authorized under Automatic Board Order (ABO) issued as Permit No. 10325, 1974 - Ferris) [Additional Reference(s): DWR Levee Log, 1990. USACE Sacramento O&M Manual Unit 120, Willow Slough Channel Relocation and Levee Construction, February 1947, Drawing No. 50-4-2281 Sheet 4 (Station 328+51)] FS Date: 5/14/2015 1:45:44 PM

Waterside view- overview
